N.S.W. PRE-PURCHASE INSPECTIONS

STANDARD BUILDING INSPECTION REPORT

ADDRESS OF PROPERTY:	<i>Address Deleted</i>
OWNER'S NAME:	<i>Name Deleted</i>
AGENT:	<i>Name Deleted</i>
GENERAL DESCRIPTION OF PROPERTY:	Double brick house constructed on timber beam and pier flooring with a substantial two storey brick veneer extension at the rear on a concrete slab at the ground floor level and timber flooring at the first floor exhibiting deterioration of the roof tiles, corrosion of the plumbing and requiring considerable other repairs as detailed
ACCOMMODATION:	Two to three bedrooms depending on the configuration of rooms
AGE OF PROPERTY:	The original house is probably 60 years old
NEIGHBOURING PROPERTIES:	Houses of varying styles and ages
WEATHER CONDITIONS ON DAY OF INSPECTION:	Dry

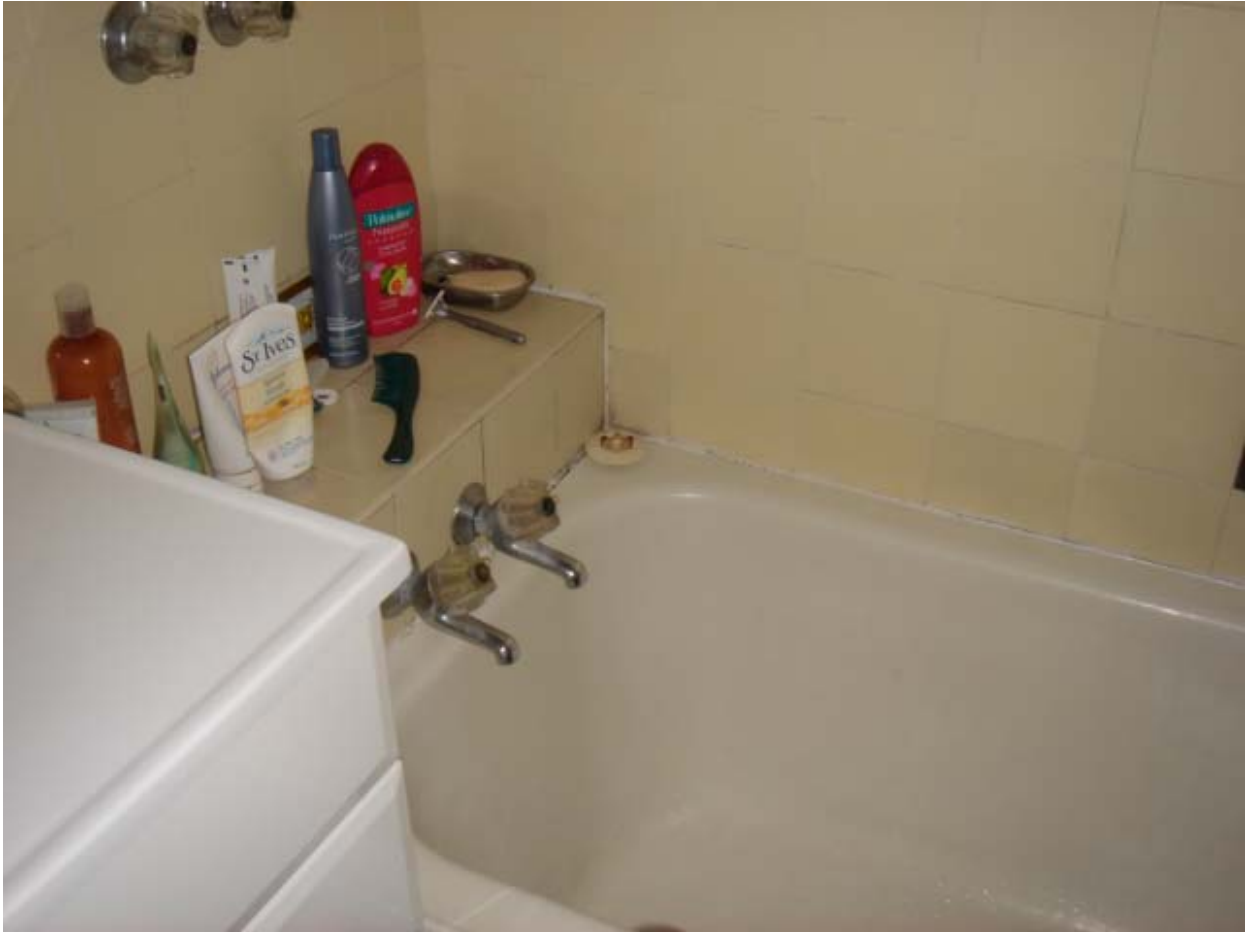
Photo 1.

Tiles in the shower enclosure are in poor condition.

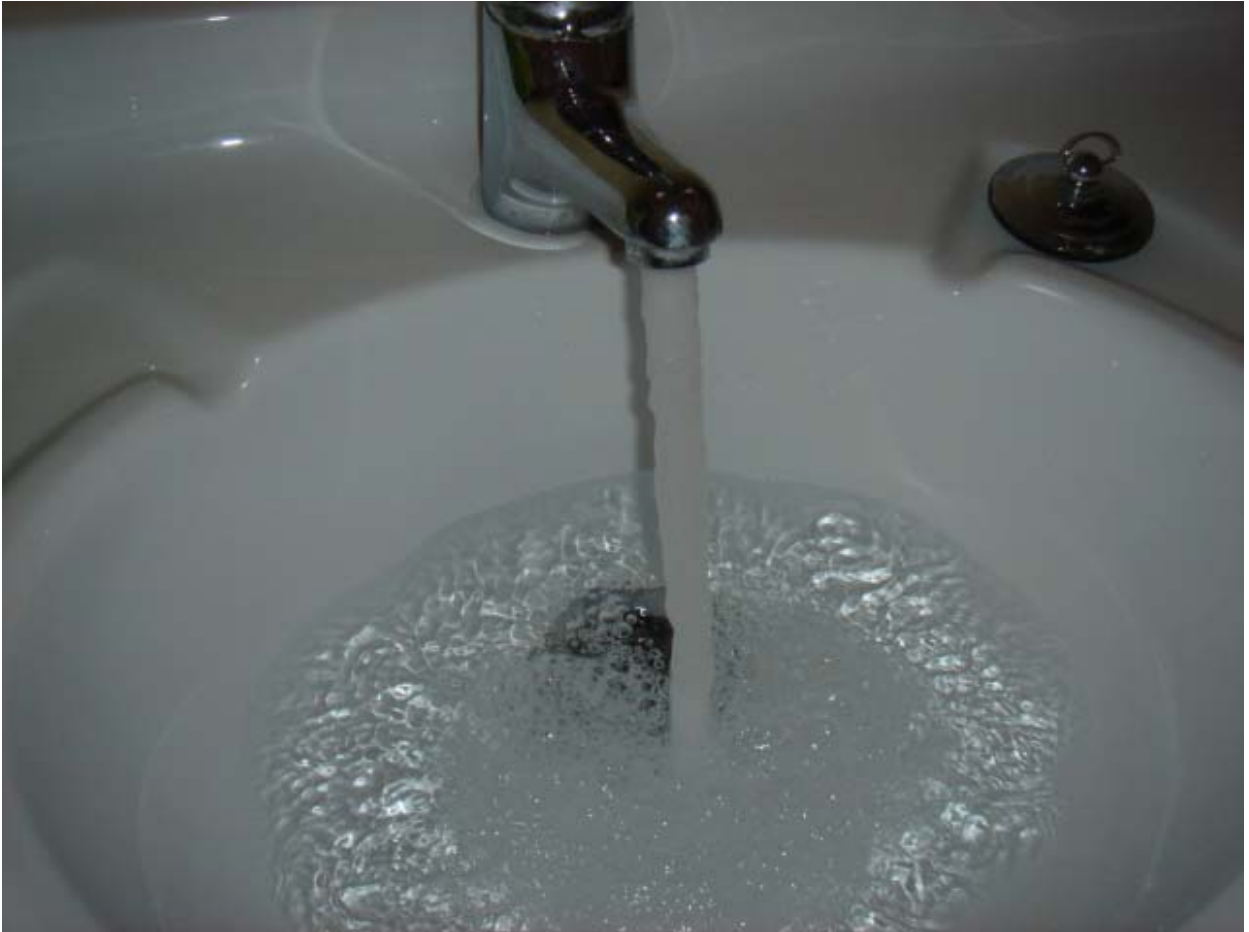
Photo 2.

The handbasin in the bathroom drains slowly.

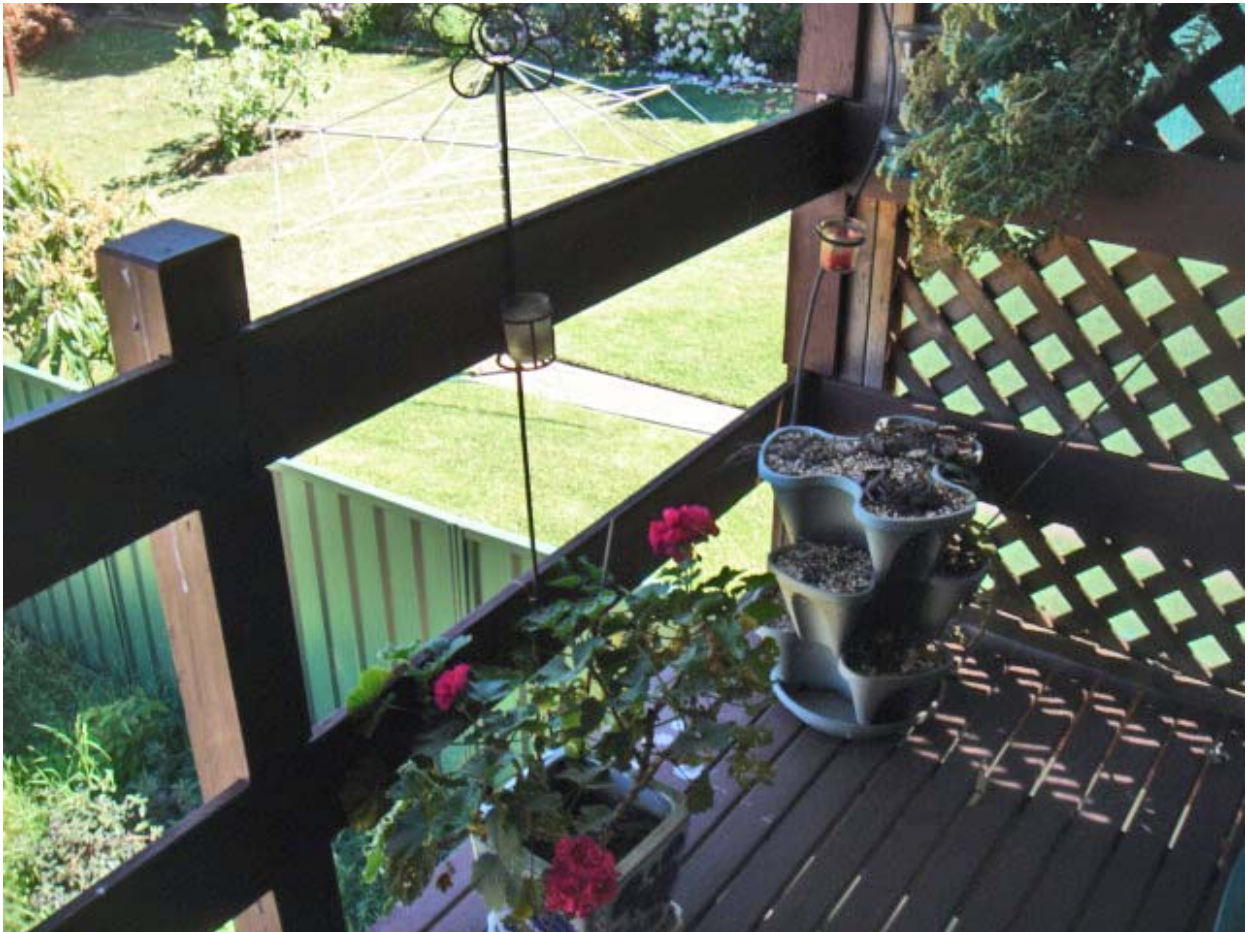
Photo 3.

- ii. Rails enclosing the balcony are approximately 900mm above the floor and do not comply with Council regulations because the Building Code of Australia states that these rails should be 1 metre above the floor for safety purposes and replacement of the rails should now be undertaken. (Photo 3) Furthermore, these rails are infirm and would also not comply with Council Regulations because children can climb over and fall through the rails.

Rails enclosing the balcony are too low and do not comply with Council Regulations or the Building Code of Australia for safety purposes.

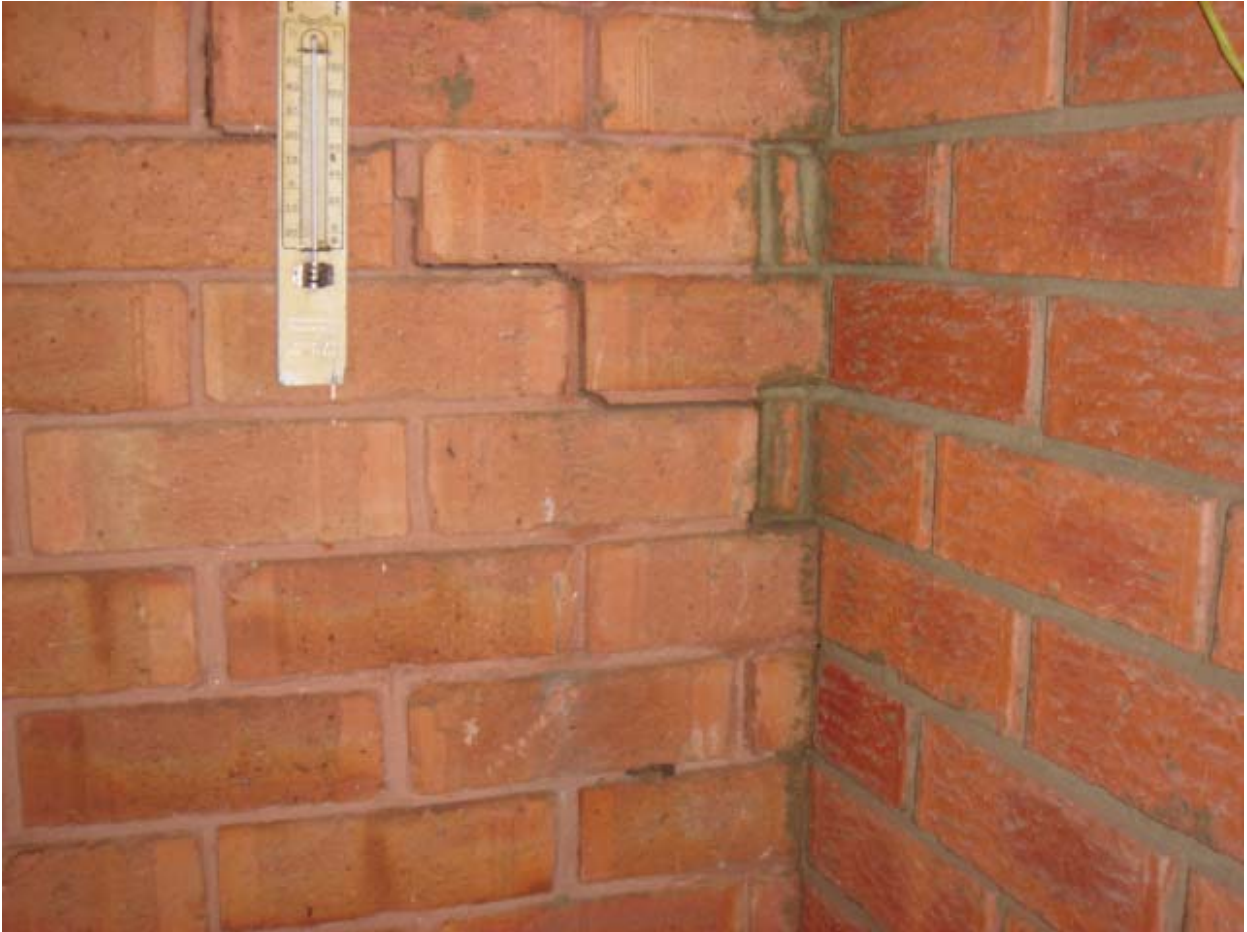
Photo 4.

2. The following conditions were noted in relation to the exterior of the house:
 - i. Considerable cracking is present in the exterior brickwork, especially in the rear wall, a condition that may indicate that the footings that support the walls are insufficient. No immediate instability has occurred, but reconstruction of a section of the wall at the rear of the house at least should be undertaken with costs being in the order of \$1,800. Nevertheless, should cracking reappear, reinforcement of the existing footings may be necessary, a process known as underpinning that can involve costs in the order of \$10,000 to \$20,000.
(Photo 4)

Considerable cracking is present in the exterior walls.

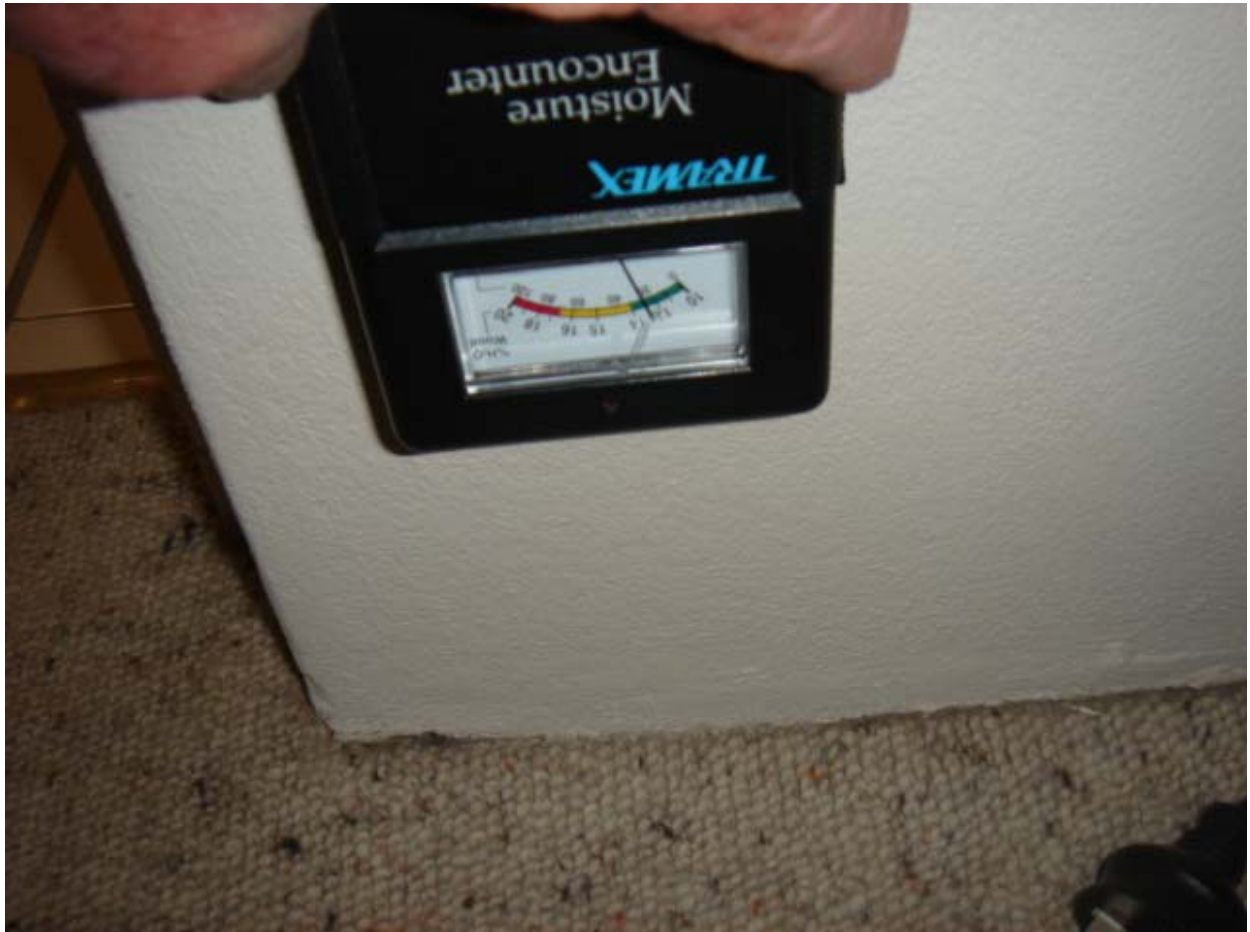
Photo 5.

1. Damp meter readings taken about the surfaces of the internal walls near the floors revealed no evidence of rising damp at the time of this inspection. Nevertheless, the current drought can conceal rising damp which may appear during normal weather conditions. Please note carefully that we accept no responsibility for any rising damp that may appear at any time in the future. (Photo 5)

Damp meter readings taken along the surfaces of the walls revealed no moisture in the walls.

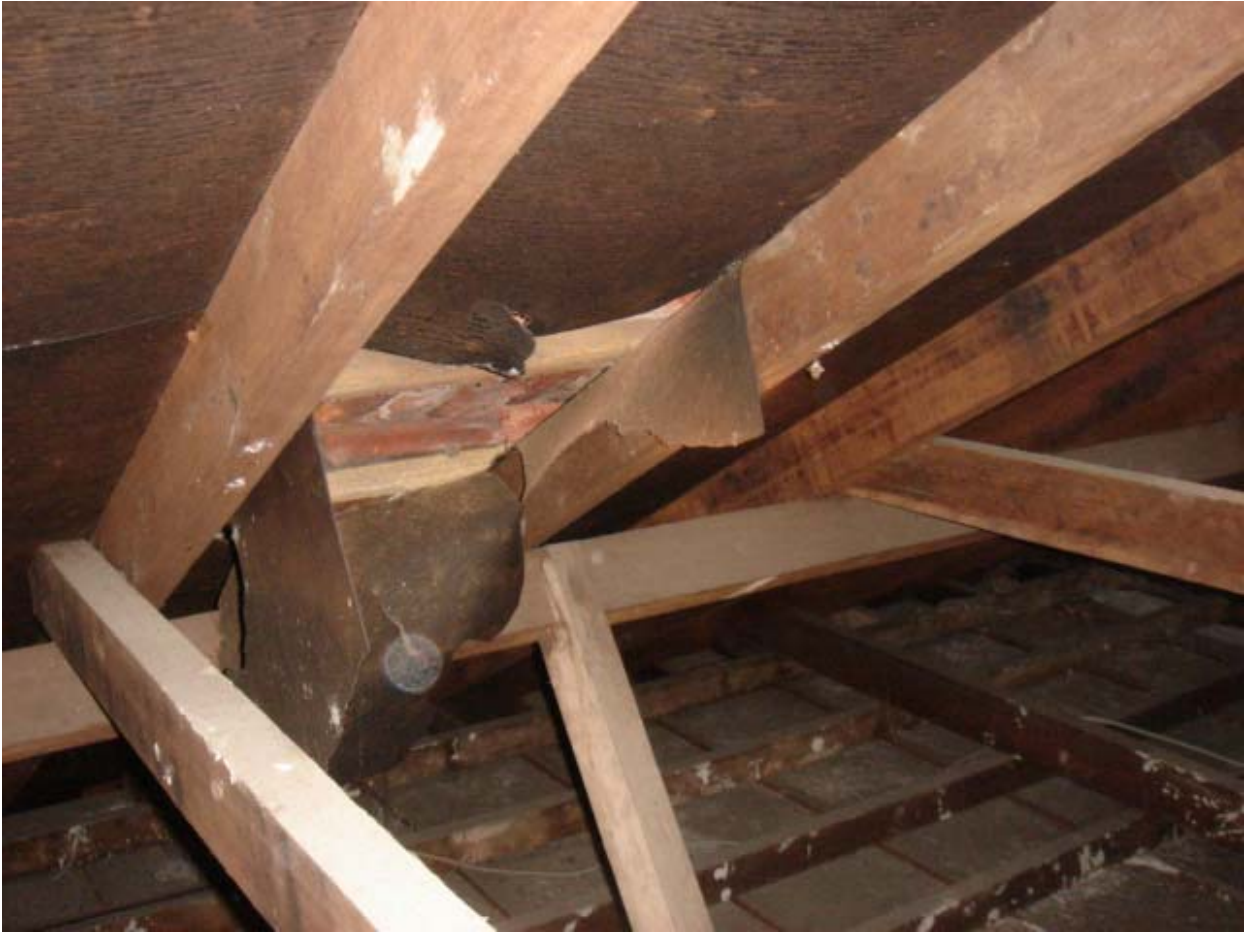
Photo 7.

- iv. The bituminous membrane lining the underside of the roof tiles is extensively torn as visible from within the ceiling cavity and replacement will be necessary when the roof tiles are renewed with costs being in the order of an additional \$2,000.
(Photo 7)

Bituminous paper lining the underside of the roof tiles is torn as visible from within the ceiling cavity.

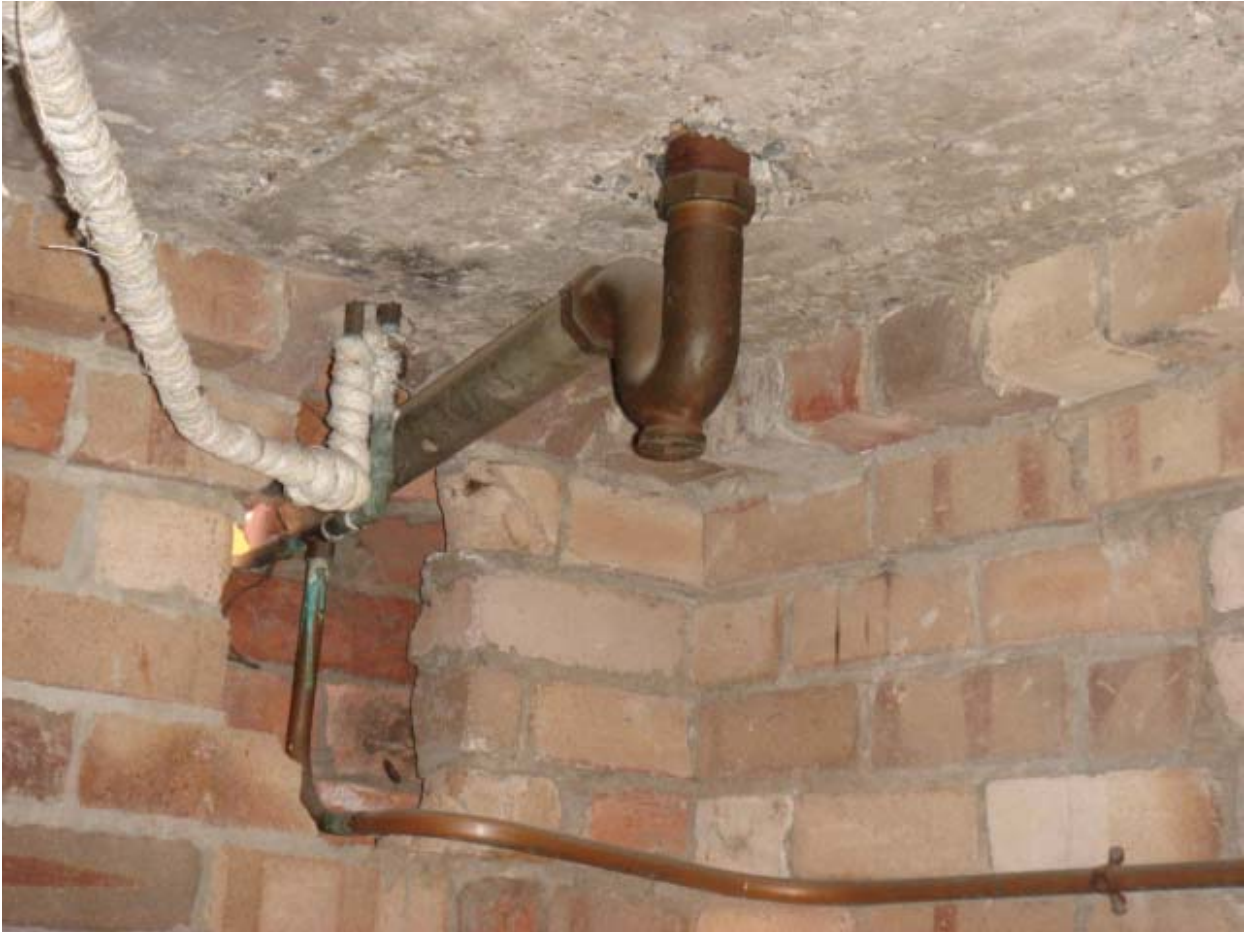
Photo 8.

7. Copper and iron waste plumbing pipes are old and now require replacement with costs involved being in the order of three or four thousand dollars depending on the extent of renewal undertaken. (Photo 8)

Iron and copper plumbing waste pipes are old.
